Somerset Tree Inventory and Assessment

Preliminary Report

Prepared by Lisa Harmison, The Ames Gardener, August 15, 2007

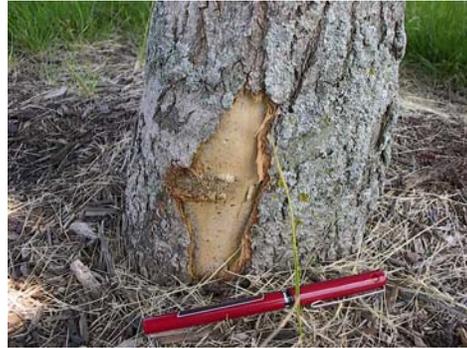
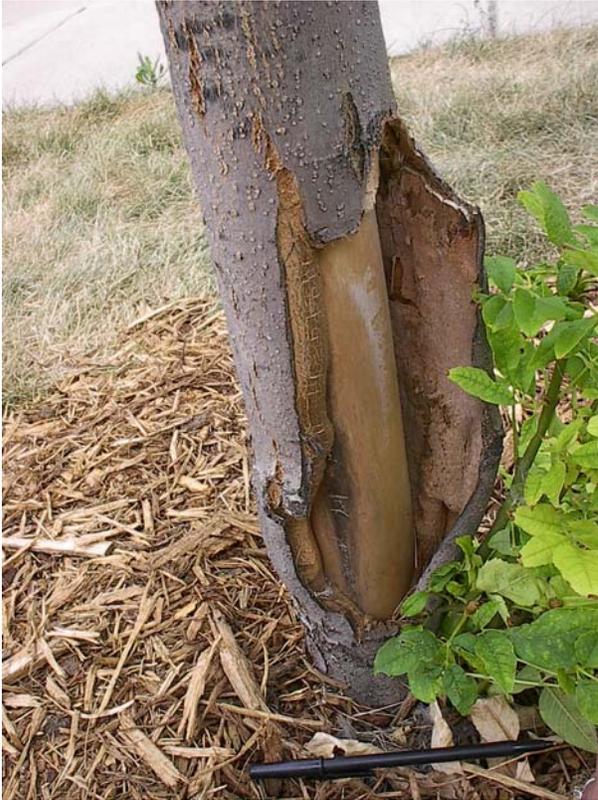
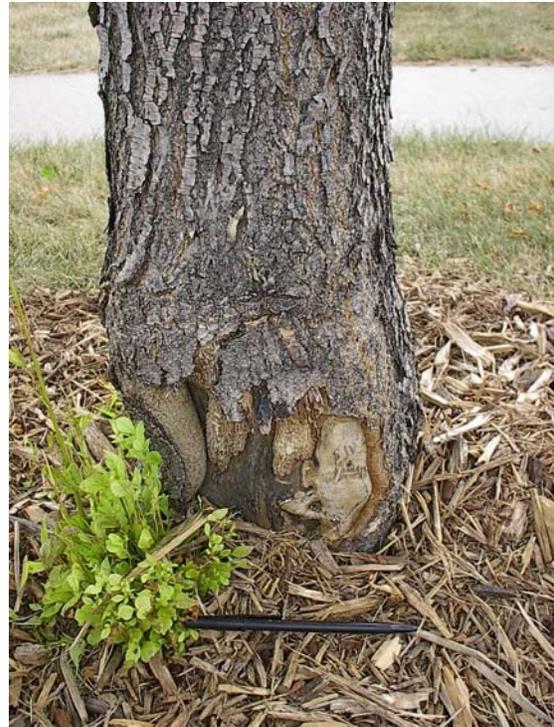
Just over half of the trees (58%) have trunk damage. Seventeen percent of the trees have mower damage. Weed whackers and vehicle doors also cause trunk damage, as does occasional vandalism. Trunk wounds are an invitation for disease and insect invasions to the tree. They also are weak spots for the stability of the tree, especially if a significant portion of the tree's circumference is damaged (over 40%) (USDA Forest Service).

It is important to reduce damage caused by lawn mowers. All trees should be mulched with as big a mulch circle as possible, up to five feet in diameter. Individual home owners need to understand the importance of protecting the trees from damage. Commercial lawn care companies need to be held responsible for mower damage they cause.

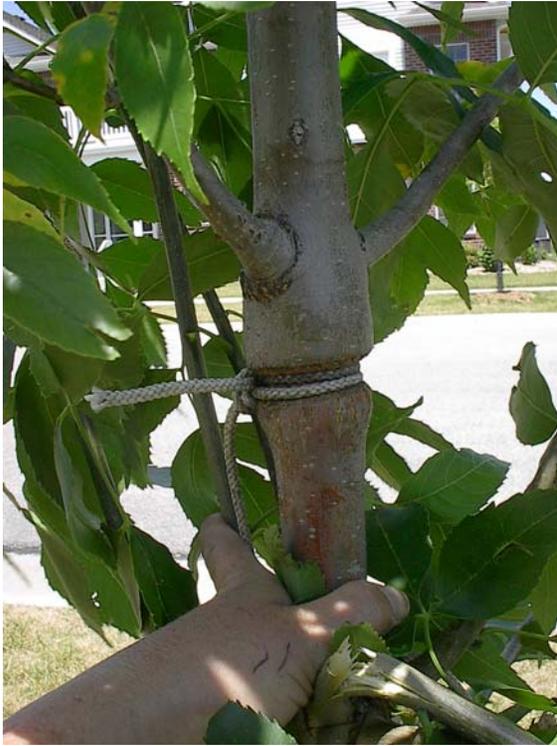
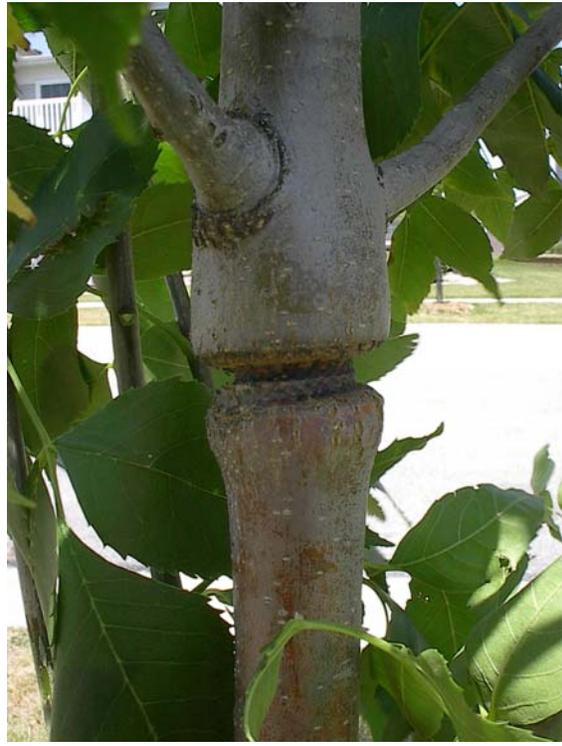
Stakes with ties and tree wraps left on the trees too long have caused injury to the Somerset trees in two ways. First the ties and wraps impair the growth of the trunk, some even strangle the tree. Second, the wraps rub the bark off the tree and cause a weak spot

that insects can use to enter the trunk.

Insects frequently attack a tree that is already stressed, i.e. wounded by the ties or by a mower. Insects noted in the inventory are ones that cause damage under the bark of the tree, weakening the interior structure and stability. Twenty-nine percent of the trees have evidence of damaging insects through exoskeletons, borer exit holes, and fresh wood shavings at entry holes.

Contrary to popular practice, it is not necessary to stake every tree. Wraps and leader ties should be removed at planting time. Trees need staking only when the tree is not strong enough to stand upright or to hold the roots or root ball when the soil is wet. Ties are removed at the end of the first growing season in nearly all cases. Material used to tie the tree should have a broad, smooth contact surface with the trunk. Material also needs to be elastic to minimize trunk abrasion and girdling. Trees grow stronger without staking, or with ties that allow them to bend in the wind (Harris, 2004).

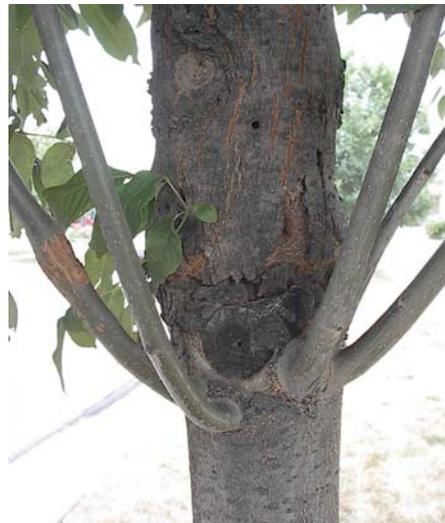
The picture at right shows epicormic shoots have grown around a spot where the tree was pruned improperly. The wound from cutting the removed branch has not callused and stimulated the growth of several epicormic shoots.

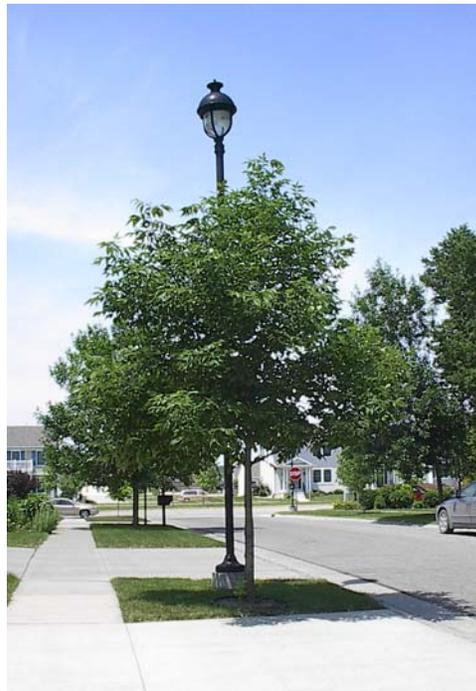
The trees planted in the sidewalk planting pits have the same stresses as the trees planted in the parking strips, but at a higher degree. The root zone area is considerably smaller; the soil is of poor quality and does not drain well. Some have no mulch. Some of the trees are planted at incorrect depths and the pits have differing soil depths. The concrete surroundings decrease the amount of rainfall that reaches the root zone. There may also be underground utilities limiting the root zone. Some pits have signs and outlets in them. The iron grates make tending to the soil surface difficult and will potentially restrict the growth of the tree and require premature removal or removal of the iron grate

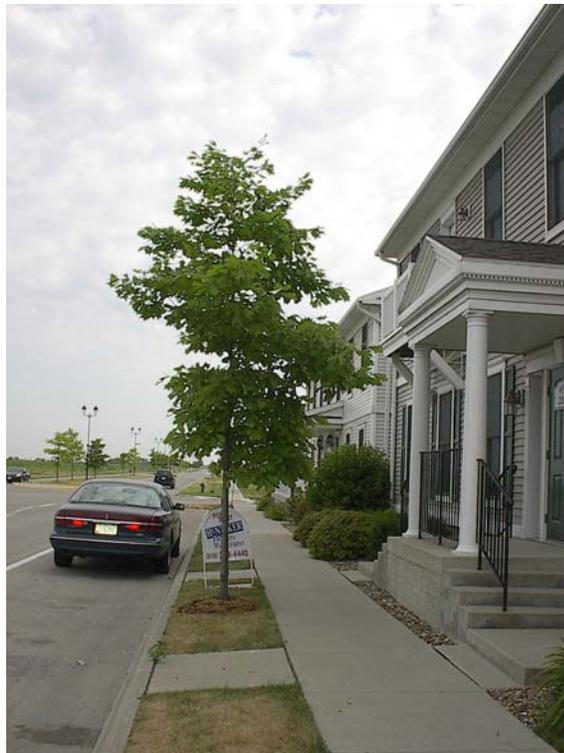
The mature size and spread of the trees planted in the sidewalk pits in the commercial area was not considered as several of the trees will interfere with the building awnings and signs. Several trees also block or will block street signs and street lights in the residential areas as well as driveways and mailboxes. The acorns and ash and maple seeds will drop onto the sidewalks and streets of some relatively high traffic (vehicle and pedestrian) areas.

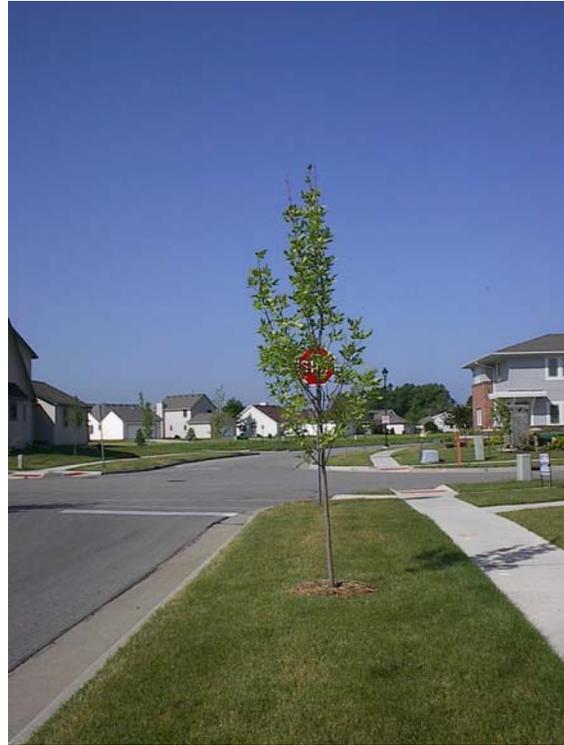
Most of the trees surveyed had some type of mulch. Most of the mulch was wood chips. There were some mulched with stone and a few with rubber tree rings. The wood mulch tended to be a little too deep and too close to the tree trunk. Mulch that is too deep blocks oxygen from the soil, tends to stay wet longer, and encourages the tree to grow shallow roots. Mulch too close to the tree trunk keeps the trunk moist. This moisture interferes with the exchange of oxygen and carbon dioxide and also creates a favorable environment for plant pathogens and insects. (Herms, 2001)

Several of the trees with the wood chip mulch need to have the mulch spread away from the trunk of the tree. Some trees also need to have the thick, volcano like mulch pile spread out to three inches deep. This can be done at any time of the year.

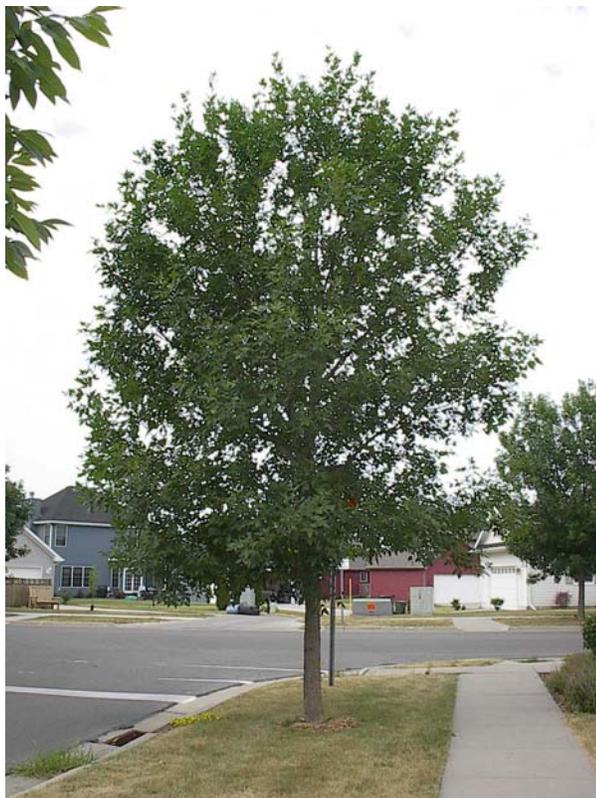
Picture to the right is of the tree at Chester and Kent before pruning. The stop sign is now more visible to drivers on Chester.
