Somerset Tree Inventory and Assessment

Preliminary Report

Prepared by Lisa Harmison, The Ames Gardener, August 15, 2007

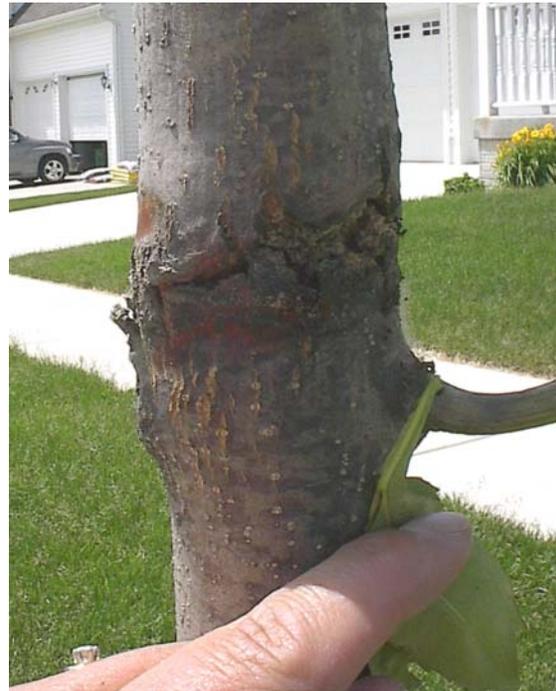
Insects frequently attack a tree that is already stressed, i.e. wounded by the ties or by a mower. Insects noted in the inventory are ones that cause damage under the bark of the tree, weakening the interior structure and stability. Twenty-nine percent of the trees have evidence of damaging insects through exoskeletons, borer exit holes, and fresh wood shavings at entry holes.

It is important to reduce damage caused by lawn mowers. All trees should be mulched with as big a mulch circle as possible, up to five feet in diameter. Individual home owners need to understand the importance of protecting the trees from damage. Commercial lawn care companies need to be held responsible for mower damage they cause.
